# Study of Failure of the Steam Tubes of Boiler Furnaces in Najebia Power Plant

Prof. Dr. Saleh E. Najim      Dr. Haider M. Mohammed  
College of Engineering – Basrah University

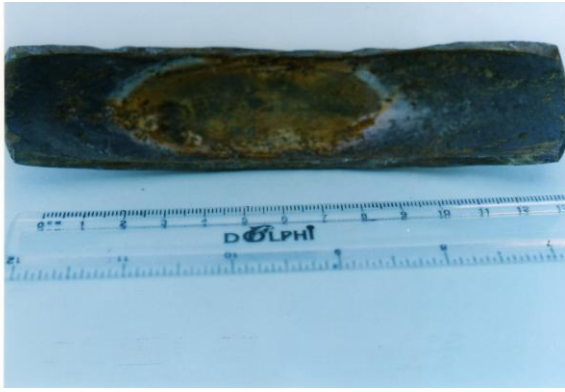
which had leaked, a heavy accumulation of black deposits and brown oxide film were found on the inner surfaces (Fig.1). Some pitting corrosion had occurred in the inner surface (Fig.2). Tubes failed by cracking (Fig.3), and the reduction in the wall thickness is also observed (Fig.4).

Fig. 1 black deposits & Brown oxide film on the inner surface

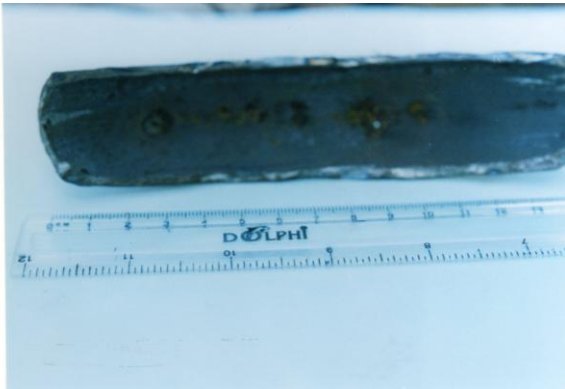
Fig. 2 Pitting Corrosion

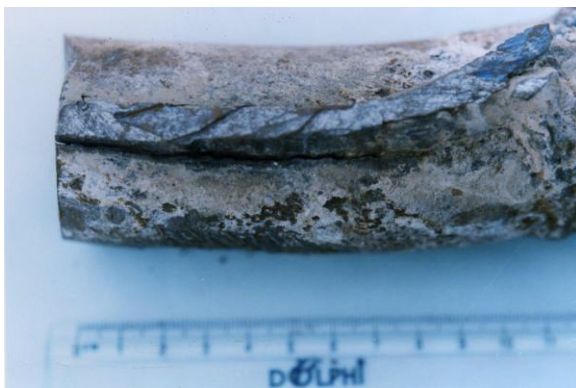
Fig. 3 Cracking in the tube

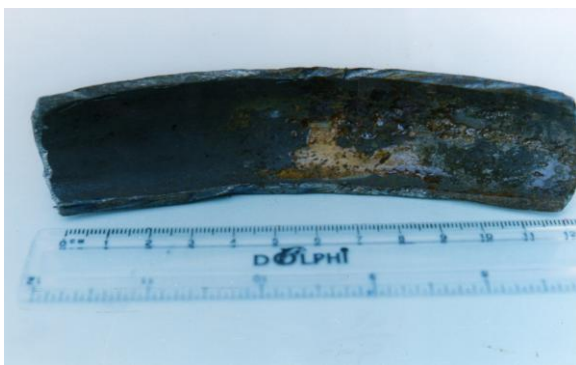
Fig. 4 Wall Thinning (Erosion)

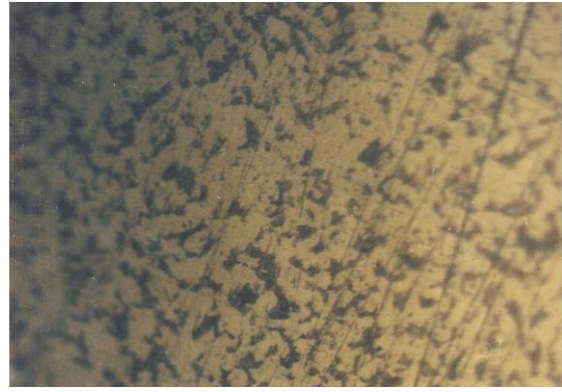
**3. Microscopic Test Results:** The microstructure of the new tube is given in Figure 5, which formed from two phases structure of pearlite and ferrite. Figure 6 shows the microstructure of the tube that failed by rupture, there was a phase transformation from pearlite to ferrite; then, the metal of the tube became weak. Figure 7 shows the microstructure of tube with cracking. This change in microstructure resulted due to overheating of the wall tubes [7].

Fig. 5 Microstructure for new tube consists of Ferrite and Pearlite (X200)

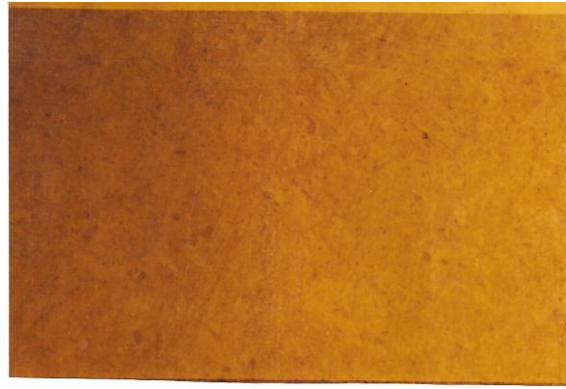
Fig. 6 Microstructure of failed tube (Ferrite only) (X200)

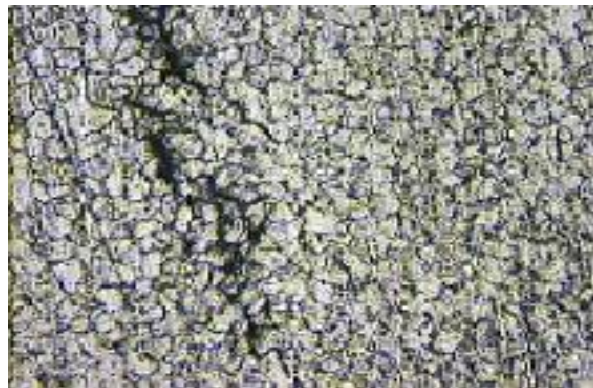
Fig. 7 Microstructure shows cracking (X200)
