EXPERIMENTAL BEHAVIOUR OF REINFORCED CONCRETE CORBELS STRENGTHENED WITH CARBON FIBRE REINFORCED POLYMER STRIPS

ABSTRACT

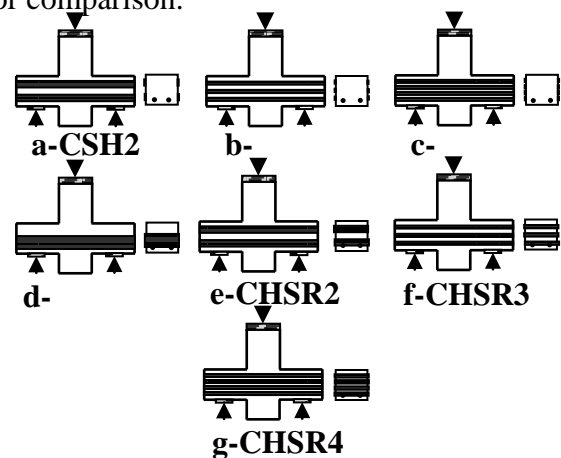
Fig. (2-1). Dimensions and Reinforcement Details.

Dimensions of the corbels are shown in Fig.2.1. The column supporting the two corbels cantilevering on either side was 150 by 150mm in cross section and 450mm long. Corbels had cantilever projection length of 200mm, with

Columns were reinforced with four deformed bars having a 12.7mm diameter and stirrups having a 6mm diameter placed at a pitch of 125mm. Reinforcement details for the corbels are presented in Fig.2.1. The primary reinforcement (main bars) having diameter 12.7mm, placed at the bottom of the beam with an effective cover of 25mm. Main bars were welded with cross bar of similar diameter, near the end of each corbels, to provide additional anchorage

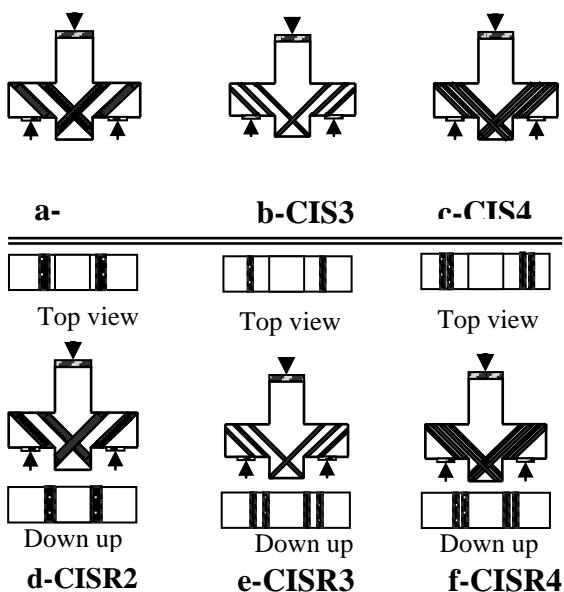
Fig.(2.3) Detail and geometry of specimens for corbel subgroup CIS and CISR

Strengthened schemes were chosen carefully based on the practical needs and the field conditions, mainly, crack pattern and practical applied in the actual and economic. In this research work, thirty corbels were strengthened with externally bonded CFRP as described below. Schematic representation of the strengthened schemes is shown in Fig. 2.2 and 2.3, twenty six of these specimens were tested with (a/d=0.7), two tested with (a/d=1.0) and two tested with (a/d=0.5). Corbels CONT1, CONT2, and CONT3 with shear span to effective ratio 1.0, 0.7, and 0.5 respectively, were kept without strengthened as shown in Fig. 2.1, they are considered as control corbels for comparison.

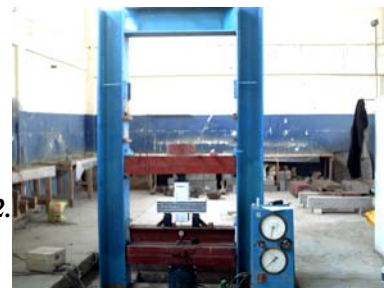
Fig.(2.5) Hydraulic system for measuring the applied load.

It is a steel box that contains a system of electrical control for operating the applied load by hydraulic pipes linked with the loading system as previously mentioned. It includes a main gauge with three divisions, with a maximum capacity of (2000 kN) Fig. 2.5. This part operates continuously during testing stages of the sample until failure.

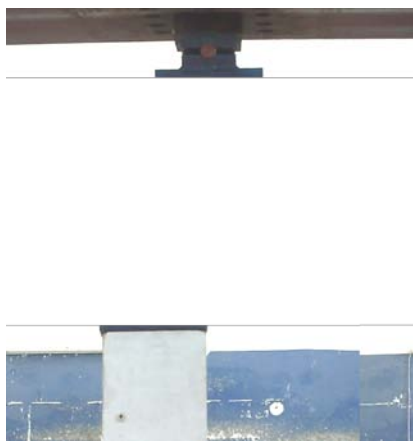
Fig (2.6) Details of the machine and frames used for testing corbels.

Corbel specimens were painted and marked, Demec discs were fixed on marking location. The corbels were then loaded as shown in Fig.2.6. vertical load on the corbel was applied by The 2000-kN hydraulic testing machine available at Al-Kuffa University Laboratory which is shown in Fig.2.5. Bearing plates of 150mm x150mm were used at loading point and at supports to avoid local crushing of concrete. Details of the machine and frames used for testing the corbels are shown in Fig.2.7.

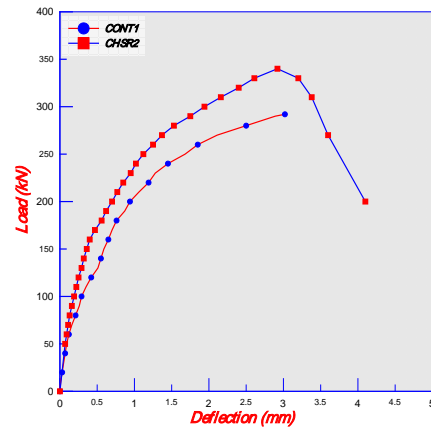
Fig.(3.5) Load-Deflection Curve of corbel (CHSR2) change in ultimate load but the deflection increases with a decrease in load due to the confinement caused by the CFRP strips". The ultimate loads were 340, 383 and 353kN for CHSR2,CHSR3 and CHSR4 respectively. Figs 3.5, 3.6, 3.7, and 3.8 shows load versus deflection curves for these corbel specimens.

Specimens of Series CHSR consisted of four corbel specimens designated as CHSR2, CHSR3, CHSR4 and CHSR1. The failure and crack patterns of series CHSR2-CHSR4 corbels were somewhat similar to those occurred in series CHS in spite of the variation in the ductility, where series specimens CHSR was more ductile" no

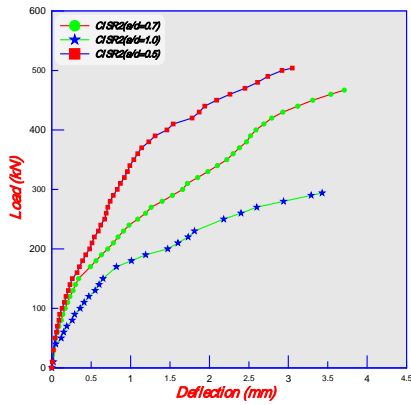
Fig.(3.18) Load-Deflection Curves of corbel C1SR2 (a/c= 0.7, 1.0 and 0.5)

The effect of shear span to depth ratio (a/d) was investigated in this research work. Corbels with two different (a/d) ratios (1.0 and 0.5) were used in addition to (a/d=0.7). These values were used for unstrengthened specimens, and with the best result of all series of strengthened corbel specimens for (a/d=0.7). Table 3.1 shows the predicted ultimate shear strength obtained using these ratios.

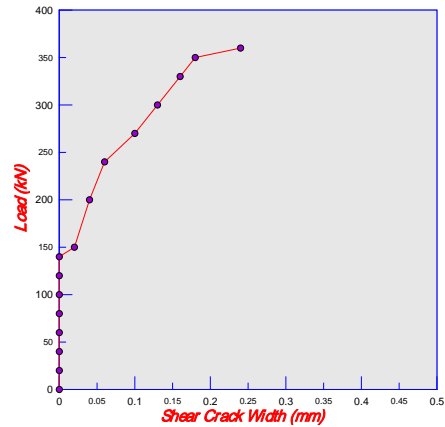
Fig.(3.20) Load-Shear Crack Width of corbel (CHS3)

For all corbels, the first cracks were flexural cracks starting at or near the junction of the tension face of the corbel and the face of the column. Shear cracking load is defined as the load at which the first major inclined diagonal tension crack appears in the shear span. Corbels without CFRP strips exhibited considerably larger crack width at failure. The data of crack width was recorded up to 90% or 95% of the ultimate load, where the final width of crack at ultimate load cannot be measured due to explosive rupture of the CFRP strips.

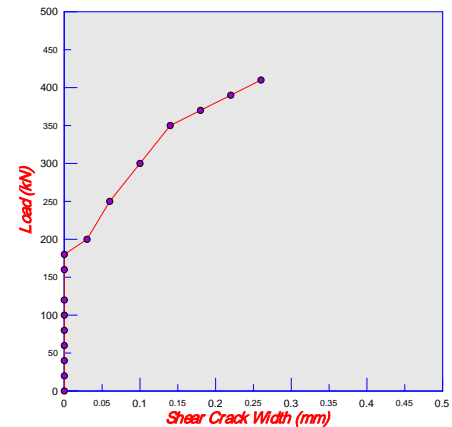
Fig.(3.22) Load-Shear Crack Width of corbel (CIS3)

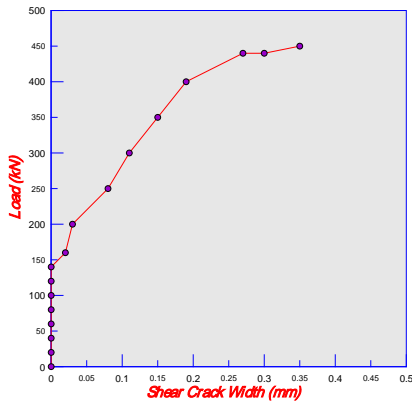
Fig. (3.24) Load-Shear Crack Width of repaired corbel (CISR2 repair)

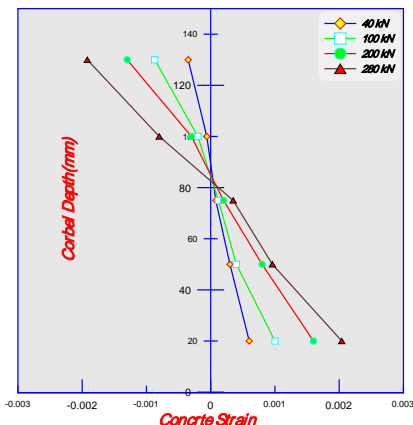
Fig. (3.25) Concrete strain distribution of Corbel (CONT1)

Concrete surface strains at a section close to column face of the tested corbels were measured by using six to ten demec discs over the depth of the corbel. Figs.3.25 to 3.28 show the concrete strain distribution over the corbel depth for all corbels at different load levels. In these figures, it can be seen that the strain distribution was approximately linear in tensile and compressive zones at low load levels, and then became increasingly nonlinear at the tension zone at higher loads due to cracking effect. For all tested corbels, the neutral axis was shifting upwards after increasing the load beyond than the load at first crack. The strains in the tension zone were measured by including widths of cracks within gauge length (not true strains) .

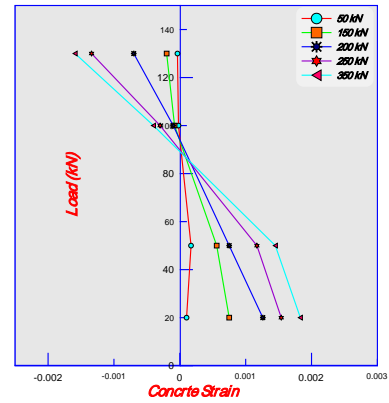
Fig. (3.26) Concrete strain distribution of Corbel (CHS3)

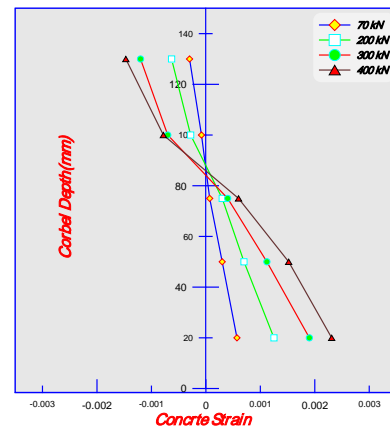
Fig. (3.27) Concrete strain distribution of Corbel (CIS3)

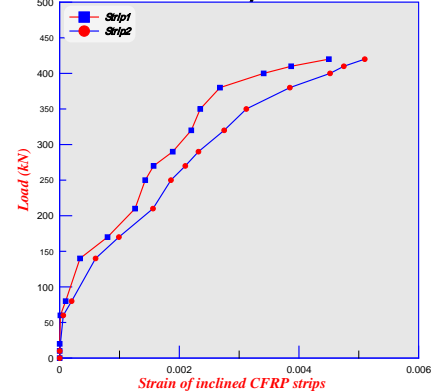
Fig (3.32) Development of tensile strain in inclined CFRP strips of corbel CIS2.

The load- FRP strains (in the direction of the fibre strips orientation) measured at the center of the strips by demec points which were placed at different positions along horizontal or inclined CFRP strips. The strain values indicated in the figs. of this section are those obtained at regions with maximum strain values as shown in Figs 3.29 to 3.38. From testing, it can be observed that the maximum strain values along each strip occur at regions

From the curves shown in these Figures, it can be observed that the strains in the CFRP strips were very small before the initiation of the diagonal shear cracks and began to increase rapidly after the formation of the shear cracks, and it can be noticed that the maximum strains occurred at the strip which lies at the middle of the shear span. Table 3.2 shows the maximum strains for all tested corbels.

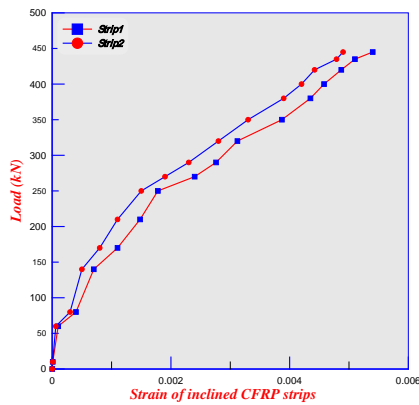
Fig (3.35) Development of tensile strain in inclined CFRP strips of corbel C1SR2.

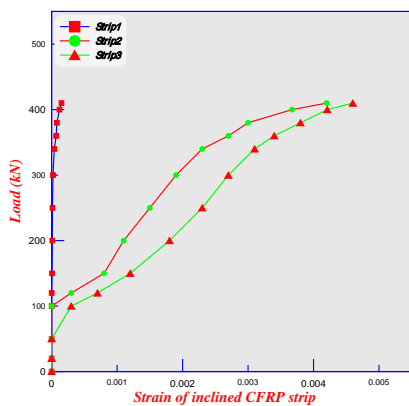
Fig (3.36) Development of tensile strain in inclined CFRP strips of corbel C1SR3.
